No Thanks to a Tornado

Standing proud on the rise of a hill near Chambersburg in south central Pennsylvania, the historic Rocky Spring Presbyterian Church withstood the attack of a short-lived but vicious tornado late in the afternoon of May 11, 1996. Built in 1794, the 3,000-square-foot elegant brick church was pummeled by winds gusting up to 100 mph as the F-0* rated tornado struck from the south, causing the collapse of the brick gable and tearing away over one third of the roof. This article focuses of the careful restoration of this cherished landmark listed on the National Register of Historic Places.

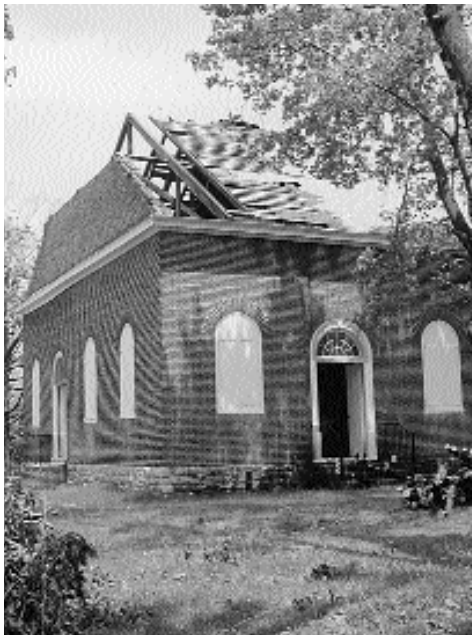
The south gable brick wall, which measured 50 feet wide and a little over 20 feet tall from the ceiling to the peak, collapsed from the impact of the winds hitting head-on. As the winds passed over the building, a vacuum was created that lifted large sections of the 60-square (a square is 100 square feet in area) roof off the south end. A 12-square section of rafters, sheathing, and roofing shingles on the east slope lifted and sailed high up over the north end of the building to land on the cemetery fence some 50 yards away. A 10-square west slope section of the roof also sailed away to land harmlessly in the west yard some 20 yards from the church. Unfortunately, the damage was not limited to the gable wall and roof.

Rocky Spring Presbyterian Church near Chambersburg, Pennsylvania, a few days after the F-0 rated tornado with 110 mph winds toppled the south gable and tore off 22 squares of roofing and rafters. Photo taken May 23, 1996.

The south gable was rebuilt using as many of the original bricks as possible and older bricks salvaged from a brick house (c. 1820) that was gutted by fire and slated for demolition. The original mortar used in the church was good quality sand, clay, and lime mixed with a visible small aggregate of streambed sediment. The new mortar was one part white mason's mortar that consisted of half stone dust and half lime, an additional one-quarter part of mason's hydrated lime and three parts of a local bank sand with a natural dark tan color. The final ingredient was one part of salvaged original mortar, which was finely ground and added to the new mix. By varying the sand color and using the older mortar reground and added to the new mortar, the firm managed to achieve an almost perfect color match to the historic mortar. After the mortar dried, it was very difficult to tell where the rebuilt section began and the older surviving section ended.

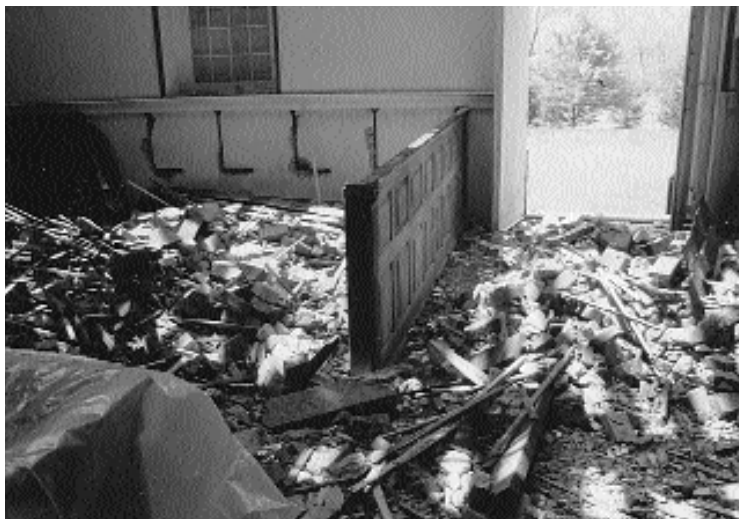
Inside the beautifully preserved sanctuary, the force of the tornado was equally evident. The pews and their paneled box walls were all original, hand planed and unpainted. The pew box doors retained the names of the families who occupied the pews. Four of these original pews and their boxes were crushed into splintered wood by the weight of the debris. Several of the surrounding boxes and pews were damaged.

Twenty-two tons of brick, mortar, plaster, lath, and framing fell to the sanctuary floor crushing four box pews and two original deacon benches. The debris was carefully sifted for all salvageable materials. Photo taken May 23, 1996.

On the interior, Preservation Associates, Inc. sifted the debris piles for all salvageable wooden components and staged them where they would dry. The crushed pews were carefully extracted from where they lay in a heap on the floor. Craftsmen experienced in restoration of damaged properties retrieved one piece of crushed wood at a time from the wreckage, identified its original location, and tagged it. The sal-

vaged pieces were assembled like a giant jigsaw puzzle and analyzed for salvation and repair versus replacement. When the few non-salvageable pieces were set aside, the craftsmen identified how much good wood was in each badly damaged piece and what portions might be salvaged for use as dutchmen to repair nicks, holes, and splintered edges in the rest of the pew wood to be salvaged.
